NPIC 'R-15/63

REEXAMINATION OF LAUNCH COMPLEX E  
TYURA TAM MISSILE TEST CENTER, USSR

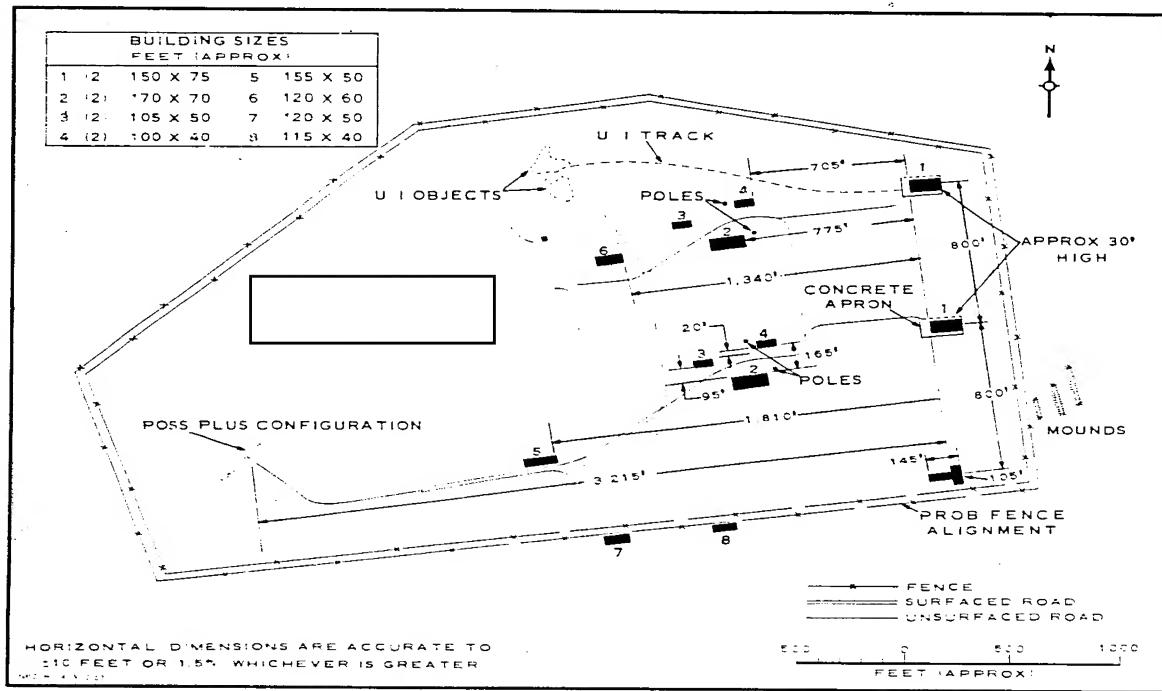
FIGURE 2. LAYOUT OF LAUNCH COMPLEX E.

Launch Complex E--located 6.5 nautical miles northwest of Launch Complex A at 45-57N 63-12E--is a confirmed launch area even though no launch pads have been identified

The only discernible change between [redacted] in the one remaining active feature--the area of unidentified activity--was the appearance of additional scarring inside and outside the fence. The area appears to be connected to the large building, 150 by 75 feet, in the northeast corner of the complex by a well-engineered track describing a very flat "S" curve between the two facilities. The exact termini of the track cannot be determined, although one end appears to go to or through two unidentified objects which may be revetments, bunkered buildings, or a revetted build-

ing. A road is evident beyond these unidentified objects. This road makes a turn of nearly 180 degrees and apparently terminates at a very small square building.

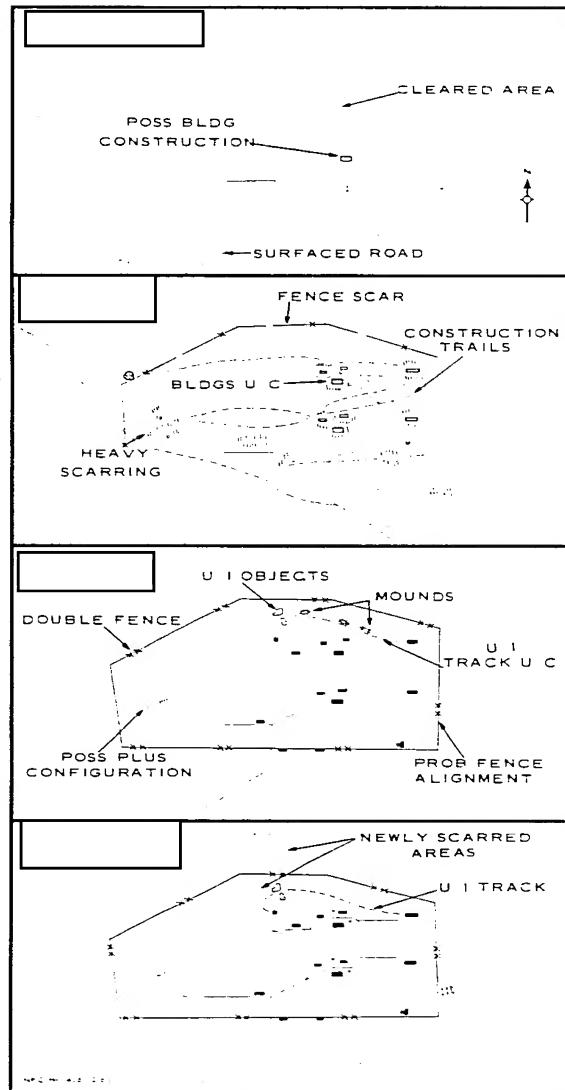
FIGURE 3. DEVELOPMENT OF LAUNCH COMPLEX E.

- 25X1D The complex was first observed in an early stage of construction on photography of [redacted]. At that time, the only activity apparent was general clearing of the area, a road, and possibly some building construction (Figure 3). A search of earlier photography of [redacted] disclosed grading for a road and a survey line running in the general direction of the area which later became Launch Complex E but no activity at the area itself.

- 25X1D The complex was again observed on photography of [redacted] which disclosed considerable activity in the area. The poor quality of this photography precluded an accurate readout of the area. Nevertheless, the extent of the activity noted on this coverage approximated the present size and shape of the complex. In addition, this photography contained indications of the presence of the eight paired buildings, although it did not permit accurate determination of their construction status. Finally, it showed heavy scarring at the location of the feature with a possible plus configuration.

- 25X1D By [redacted] the complex appeared as an irregularly shaped, secured area measuring approximately 4,500 by 2,900 feet and containing about 14 buildings. Two of these buildings, because of the quality of the photography, were identified as launch points E1 and E2. Photography of [redacted] clearly showed these to be buildings. On this later photography, no launch points as such are identifiable, nor can any specific buildings be identified as missile checkout buildings.
